# **Guidance for Service Termination Issue Reporting**

A guide for MOCOPA Operators on	reporting	and acting	on
Distribution Business asset	condition	issues

Version: 3.7

Date: July 2021

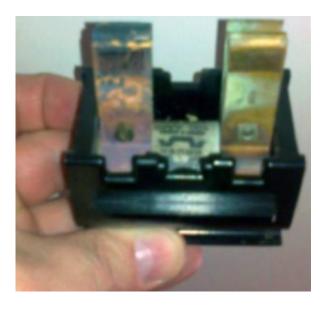
#### Weakened fuse carrier contacts

When fuse carriers become overheated they lose their "springiness".

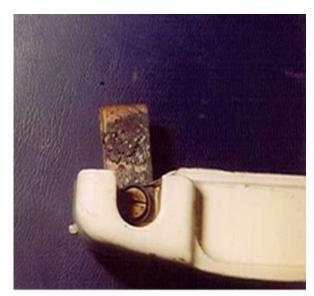
### Pitted blade, due to making poor contact

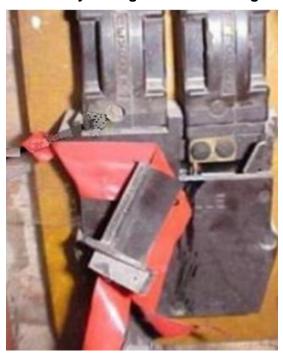
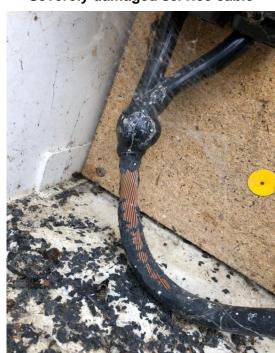
- Squashed / deformed service cables (e.g. the cable is squashed flat);
- Cables with severely damaged outer sheathing (e.g. where the conductor itself is visible). As
  the extent of the service cable damage is often unknown, severely damaged service cables
  should be reported as A04 regardless of the supply earthing arrangement.

Severely damaged service cable

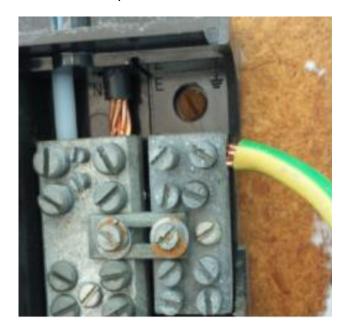
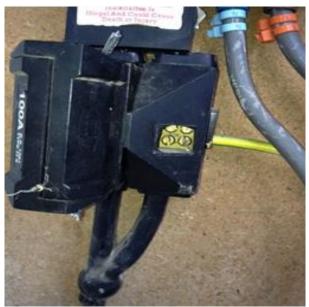
PME **c**ut-out damaged (but not requiring immediate action) with neutral-earth terminal exposed by missing cover – report as Code C20

Knock out missing and the neutral-earth is exposed – do not report

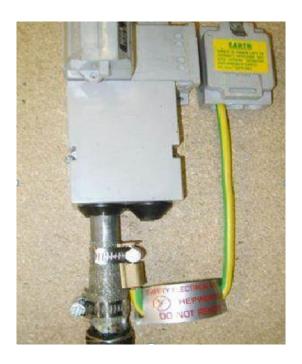
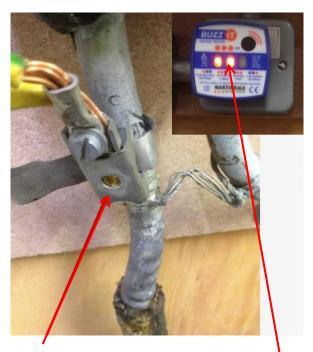
Screw missing from the earth clamp.

Socket tester indicates an earthing issue but further tests are required to confirm that the whole installation is not adequately earthed. If confirmed. Report as Code A10.

The photos below illustrate an earth connection using an earth clamp around the sheath of the service cable. If the clamp/connection is loose, do not tighten it, as this could potentially lead to cable damage and catastrophic failure. Loose earth connections attached to other parts of the DB equipment e.g. on a terminal at the side of a cut-out, may be tightened.

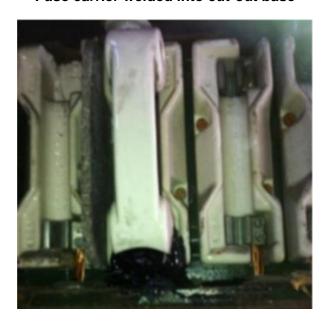
### Fuse carrier welded into cut-out base

A fuse has become stuck due to bitumen compound rising up from the cable box beneath and "gluing" the fuse contacts

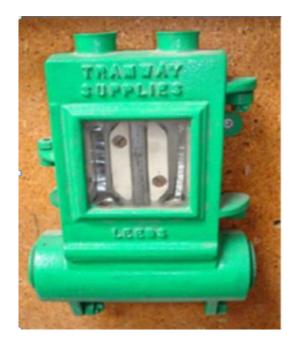
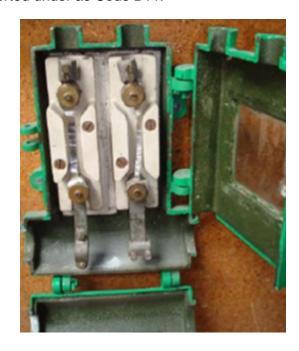
### **Examples – Non-withdrawable fuses**

The photos below show an example of a cut-out where the fuse wire terminals are attached to the cut-out, hence the fuse is non-withdrawable by design. Although note that this particular cut-out also contains a fused neutral and would therefore be reported under as Code B11.

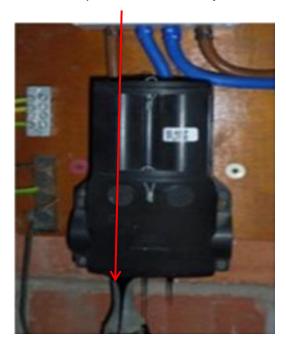
- There is no evidence of the DB equipment currently operating hot;
- The DB equipment appears in all other respects to be in good condition; and
- Compound has obviously leaked from the cut-out previously but is not currently leaking.

If the compound is currently leaking, report as Code A01.

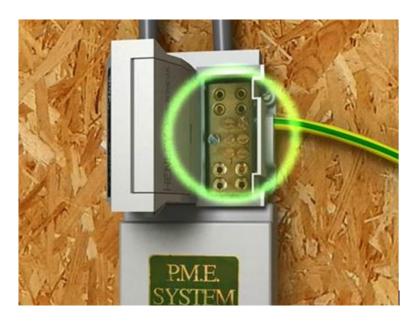
- Missing combined neutral-earth covers forming part of the DB equipment;
- Missing cut-out crutch cover where no other protection is installed (e.g. insulated 'Y piece' shroud) and the neutral-earth conductor is un-insulated;
- Missing neutral-earth terminal access covers that cannot be remediated by the Meter Operative.
