# **Guidance for Service Termination Issue Reporting**

A guide for MOCOPA Operators on	reporting	and acting	on
Distribution Business asset	condition	issues

Version: 3.7

Date: July 2021

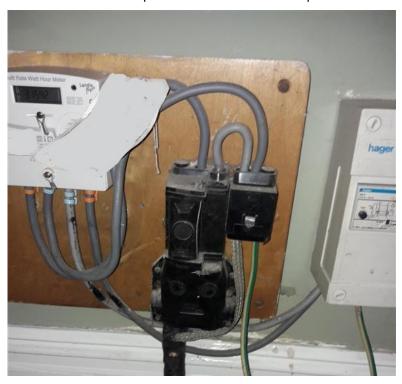
The photo below shows an example of the scenario that is reportable to the DB.

Category B – Remedial Work								
DB	DB work required for you to complete your work							
Asset Condition Code:	Code Description:							
B08	Jnhinged metal cut-out cover over un-insulated							
	conductor

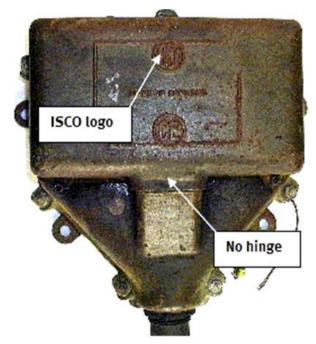
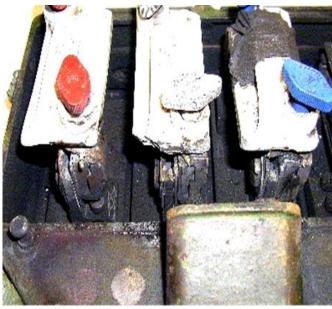
A typical example of a metal-encased cut-out which has known design deficiencies is the ISCO Type cut-out and extreme caution must be exercised when removing or replacing lids on this type of equipment. This particular example also had the phase barriers removed. All cut-outs must be assessed individually prior to attempting any live work on them ensuring that the phase barriers are in place.

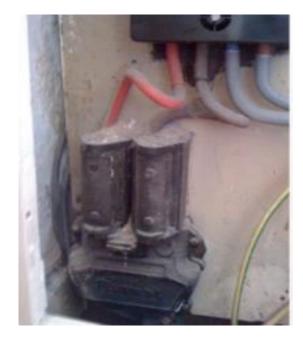
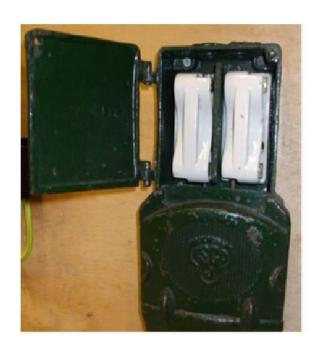
### **Examples:**

- Wherever possible, for safety and security reasons ensure the DB equipment is sealed before leaving site;
- Stop work and do not commence your meter installation activity;
- Report the issue to the DB via the data flow system report as Code B11;
- Provide the DB with the customer's name and contact number using the data flow system;
- To ensure the customer is fully aware of next steps, leave a Category B Customer Notification Card (or equivalent) to advise the customer to expect communication from the DB requesting an appointment to visit site to inspect the DB equipment.

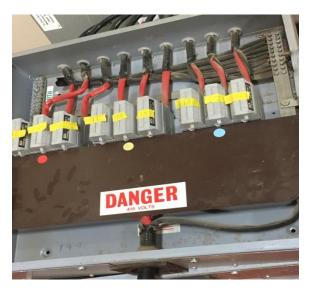
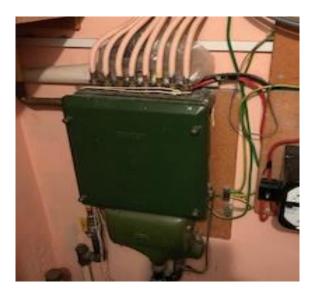
The service cable is fed from an internal distribution board within the building. Use this Code when the distributors' fuse, which supplies the customer, sits in a distribution board. This includes:

- Landlord distribution boards (Building Network Operator);
- Meters relying on a distribution board fuse for protection, regardless of whether the meter has local isolation; and
- DB owned distribution boards.

As you can only report one Code per service position, the priority of the below issues/information is in the order that they should be reported. So, for example, if you have identified that the service cable is fed from a distribution board providing there are no other higher priority issues/information, Code C14 should be reported with details of any other reportable characteristics in the free text field.

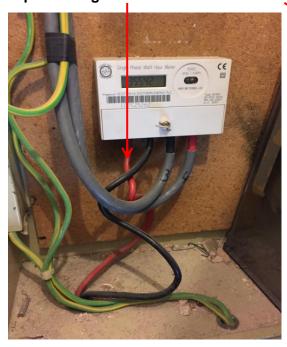
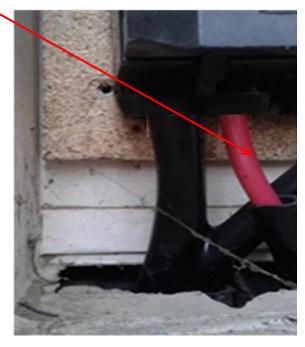
Examples - single insulated service cables

Report exposed combined neutral-earth conductors associated with PME electricity services as Code C20 if not mechanically protected.

As you can only report one Code per service position, the priority of the below issues/information is in the order that they should be reported. So, for example, if you have identified that the cut-out has a single insulated conductor, providing there is no category A or B issues present, Code C19 should be reported with details of any other reportable characteristics in the free text field.
